Precision Property Inspections LLC Property Inspection Report

517 E. Center Street, Clayton, NJ 08312 Inspection prepared for: Home Owner Real Estate Agent: -

Date of Inspection: 4/6/2013 Time: 11:30 A.m. Weather: Sunny

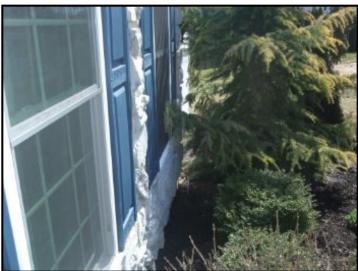
• Prune or remove any plants that are in contact or proximity to home to eliminate pathways of wood destroying insects.

Prune trees

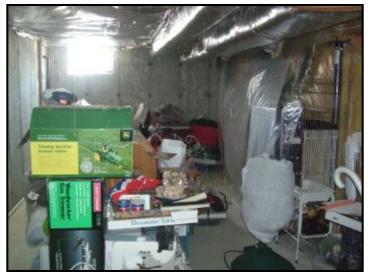
• Poured foundation floors were observed in basement and crawlspace and No deficiencies were found. Some areas of floor were covered with clutter

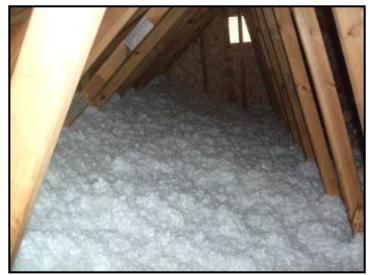
Materials: Blown in fiberglass insulation noted. Depth: Insulation averages about 10-12 inches in depth or deeper in most areas Observations:

• Insulation appears adequate.

Heavy Insulation

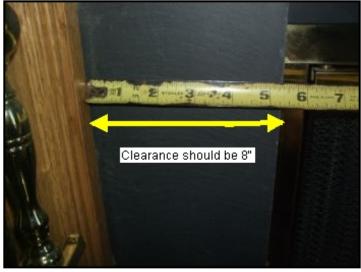
• Wood burning fireplace in Family room was checked, Damper functioned properly and Flue appeared to be cleaned from visible ares. Combustible clearances for wood burning fireplaces are 16" in front and 8" on sides. Fireplace side clearance was not 8". Recommend extending combustible clearances before fireplace is used to heat the home.

Clearance

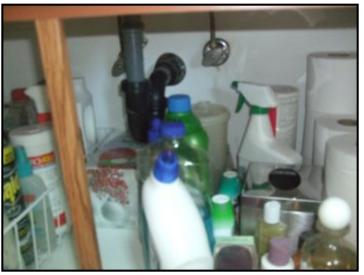
- Most not accessible due to stored personal items.
- No deficiencies observed.

Personnel items under bathroom sinks

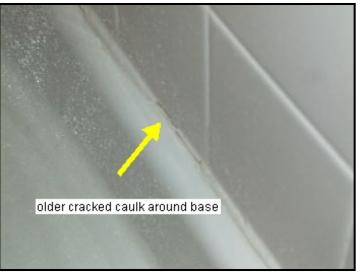
• Shower base showed signs of older caulking around it. Although no signs of a leak were present at time of inspection, Inspector recommends shower base caulk be repaired to prevent future leaks.

Repair caulk around master shower

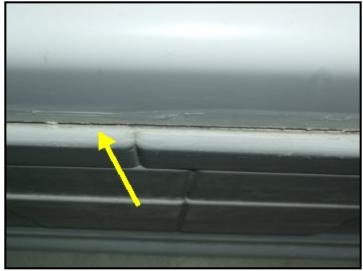
- Tub
- Some caulking repair needed at tub in Master Bathroom.

Master bath tub

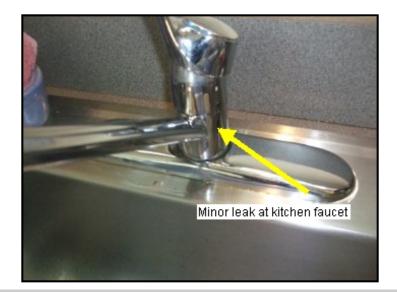
• Faucet leaks at base of kitchen sink. Owner of home was aware of leak and notified the inspector. Owner said plumber was scheduled to repair leaky faucet. Recommend service be verified before settlement

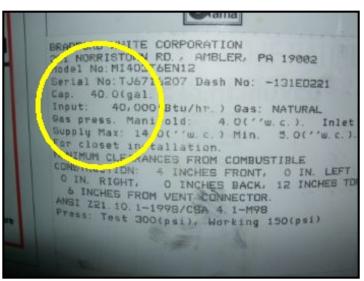
• 40 gallons

40 gallon heater

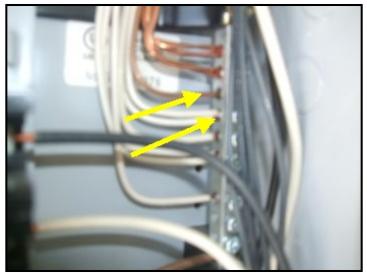
• Neutral wires are current carrying conductors(white wire), therefore they should not be terminated under the same screw on neutral buss. If connection is loose on one of conductors arcing could happen and circuits heat up. neutrals should terminate separately Recommend a qualified electrician correct issue

double tapped neutrals

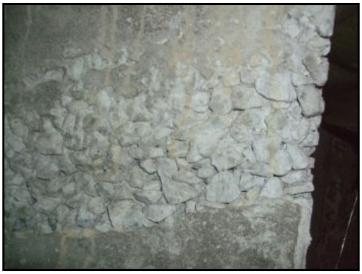
• Area of poor workmanship noted on wall in crawl space. this does not appear to be a area for concern

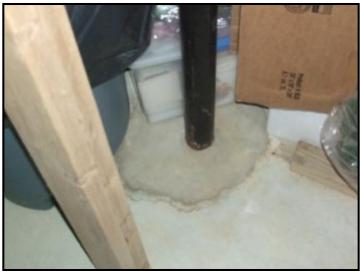
- No deficiencies were observed at the visible portions of the structural components of the home.
- Steel column appears to have been added and new footer appears to have been installed

Area of new footer
